CONFIDEA G4

RELEASE NOTES

LATEST UPDATE: 2025-08-21 (V7.14.1-1)

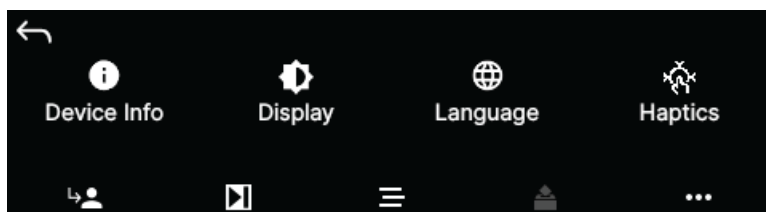
Device info on FLEX screen:

- At start-up of units there is a chance microphone audio doesn't work. (TCS_G4_1733)

This is the case for units with product version \geq rel 1.06

The version used in the unit can be checked as follows:

- Start unit
- Press configuration wheel at upper corner of the screen
- Go to device info screen

- If version indicates 1.06 or higher an update to CRP1.6.3 is required.
