CONFIDEA G4

RELEASE NOTES

CONFIDEA G4 1.6.3

IMPORTANT UPDATE REQUIRED

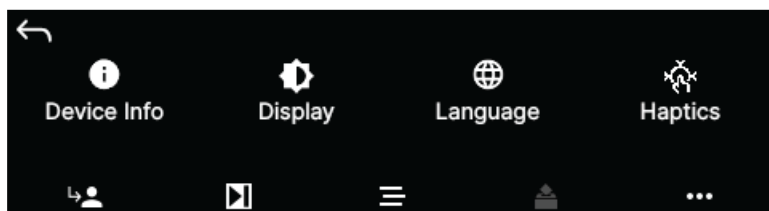
Device info on FLEX screen:

- At start-up of units there is a chance microphone audio doesn't work. (TCS_G4_1733)

This is the case for units with product version \geq rel 1.06

The version used in the unit can be checked as follows:

- Start unit
- Press configuration wheel at upper corner of the screen
- Go to device info screen

- If version indicates 1.06 or higher an update to CRP1.6.3 is required.
