CONFIDEA G4

RELEASE NOTES

LATEST UPDATE: 2024-07-18 (V7.11.25)

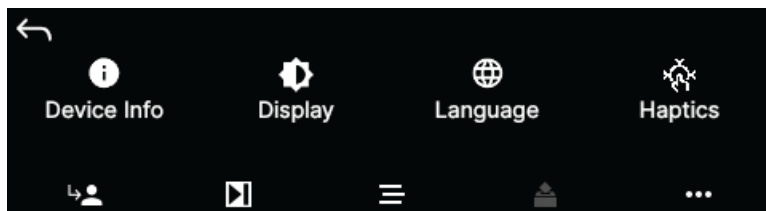
- At start-up of units there is a chance microphone audio doesn't work. (TCS_G4_1733)

This is the case for units with product version \geq rel 1.06

The version used in the unit can be checked as follows:

- Start unit
- Press configuration wheel at upper corner of the screen
- Go to device info screen

- If version indicates 1.06 or higher an update to CRP1.6.3 is required.
