CONFIDEA G4

RELEASE NOTES

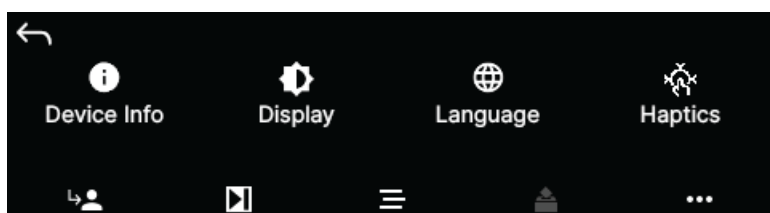
Device info on FLEX screen:

- At start-up of units there is a chance microphone audio doesn't work. (TCS_G4_1733)

This is the case for units with product version \geq rel 1.06

- If version indicates 1.06 or higher an update to CRP1.6.3 is required.
