CONFIDEA G4

RELEASE NOTES

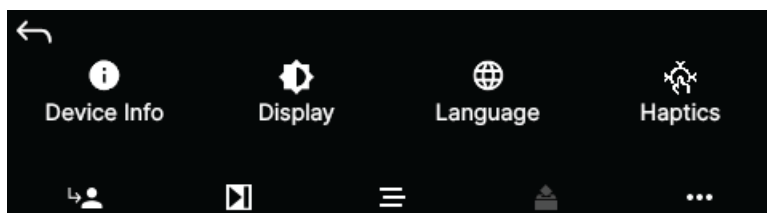
Device info on FLEX screen:

- At start-up of units there is a chance microphone audio doesn't work. (TCS_G4_1733)

This is the case for units with product version \geq rel 1.06

The version used in the unit can be checked as follows:

- Start unit
- Press configuration wheel at upper corner of the screen
- Go to device info screen

- If version indicates 1.06 or higher an update to CRP1.6.3 is required.
